FLOOD MANAGEMENT STRATEGIES IN FREQUENT AND SMALL SCALE EVENTS: LESSONS LEARNED FROM AMARANTE (PORTUGAL)

TEDIM F. & CARVALHO S., 2010. Flood management strategies in frequent and small scale events: lessons learned from Amarante (Portugal). *Quaestiones Geographicae* 29(3), Poznań 2010 pp. 69–84, 10 Figs, 6 Tabs. ISBN 978-83-62662-04-3. ISSN 0137-477X. DOI: 10.2478/v10117-010-0024-3.

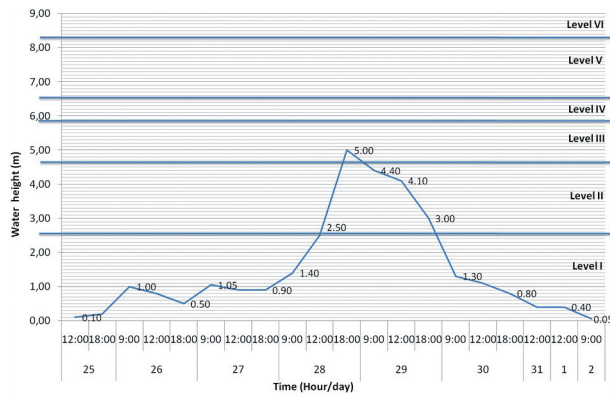
Fig. 5. January 1948 flood.

Source: Data from the National Water Institute (INAG).

Only one level III flood was registered during this period, beginning on January 25th 1948 and lasting until February 2nd of the same year. The flood holded level III for less than a day and level II for less than 2 days. The peak was reached on January 28th (Fig. 5).

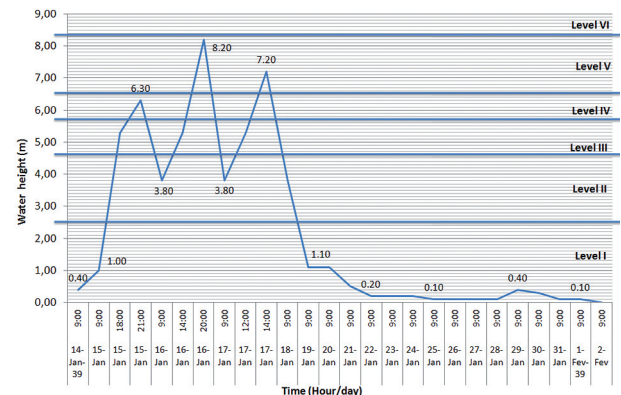
Fig. 6. January 1939 flood.

Source: Data from the National Water Institute (INAG).

The flood that reached level V happened on the 16th of January 1939. It had the duration of 20 days and begun on January 14th and ended on February 2nd (Fig. 6). Nevertheless, only during three days it reached level II or higher. It is possible to conclude that highest levels of flood have a short duration. During this event it is possible to identify three flood peaks.
